StarFire™ 6000 and StarFire™ 6000 Integrated Receiver

Software Update 20-2 Release Notes
4.40P

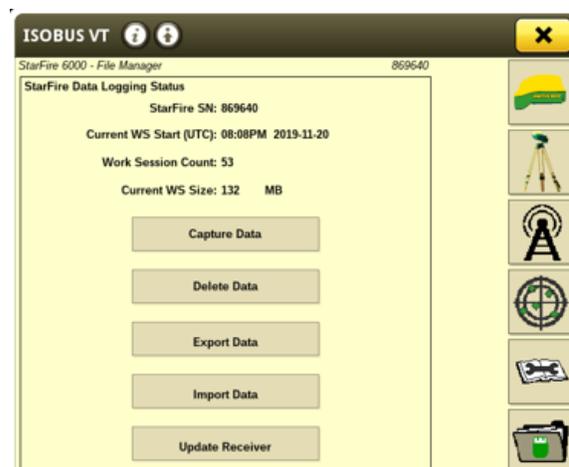
Continuous Data Logging

Diagnostic information is continuously logged internally on the StarFire™ 6000 receiver as individual work sessions from ignition on to ignition off with a maximum work session length of two hours. When a work session exceeds two hours, a new work session will automatically begin. Up to 48 hours of work sessions can be recorded.
